Sediment Source Assessment on Peachland Creek District of Peachland

January 29, 2015

File: 0655.0180.01

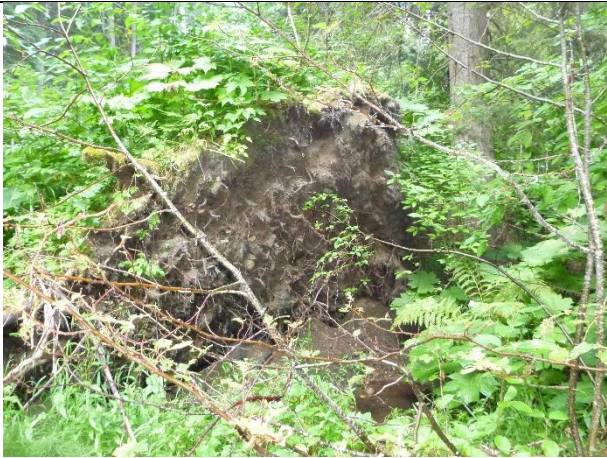
<p>Photo #3</p> <p>Location: 49.83078N 119.95726W Peachland Creek</p> <p>Notes: Exposed root wad, large woody debris (LWD). Excellent fish habitat. Downstream of tributary entering north of channel (left bank looking downstream). Bar deposited at mouth of tributary.</p>

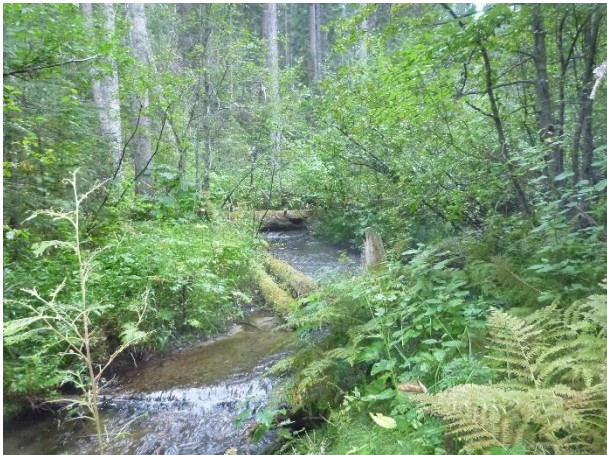
<p>Photo #4</p> <p>Location: 49.83156N 119.95095W Peachland Creek</p> <p>Notes: Reach Break. Channel is stable with properly functioning mature conifers riparian zone. No disturbance. Moss covered banks. 3% channel slope. Ripple-pool cobble channel classification. LWD, excellent fish habitat.</p>

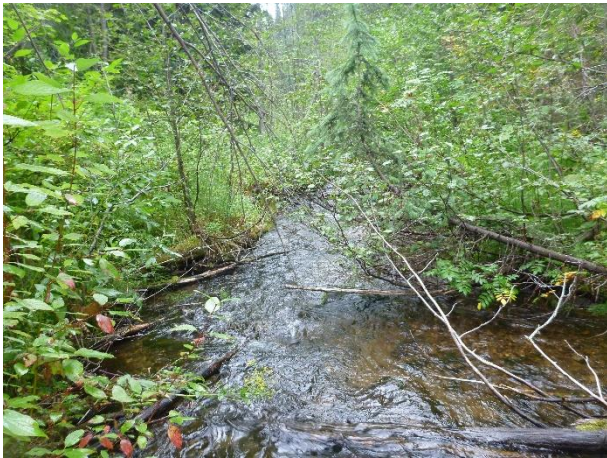
<p>Photo #5</p> <p>Location: 49.83293N 119.949128W Peachland Creek</p> <p>Notes: Reach break. Channel is stable, confined, with properly functioning mature conifer riparian zone. Moss covered boulder/cobbles. 5% channel slope. Natural undercutting, no disturbance. Cascade-pool boulder/cobble channel classification. LWD present.</p>

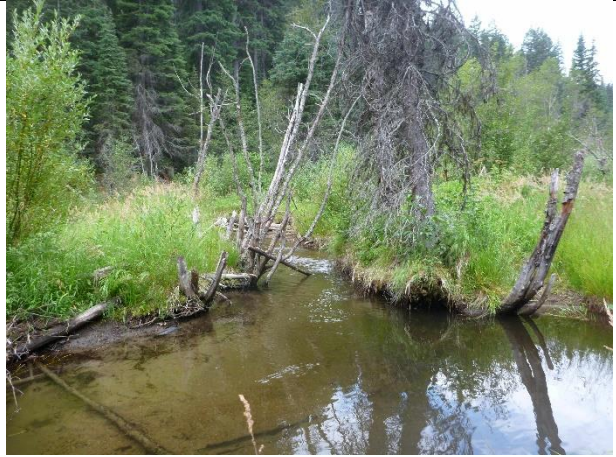
Reach break. Upstream of meadow created by beaver dam downstream ~20m. U-shaped valley. 1% slope. Ripple-pool gravel stable channel.

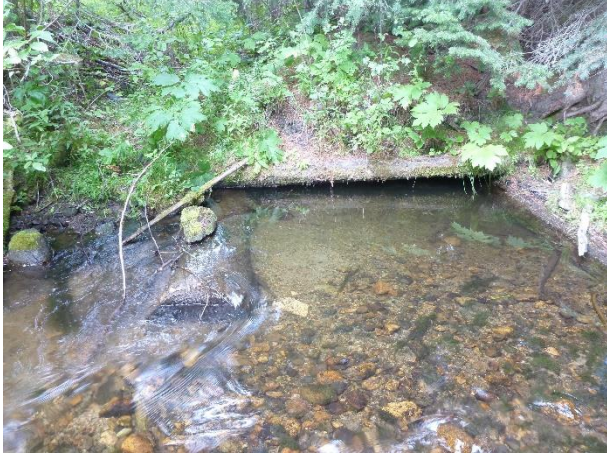
<p>Photo #7</p> <p>Location: 49.83371N 119.9307W Peachland Creek</p> <p>Notes: Wood culvert, overgrown road crossing. No current erosion</p> <p>Risk: Low</p>

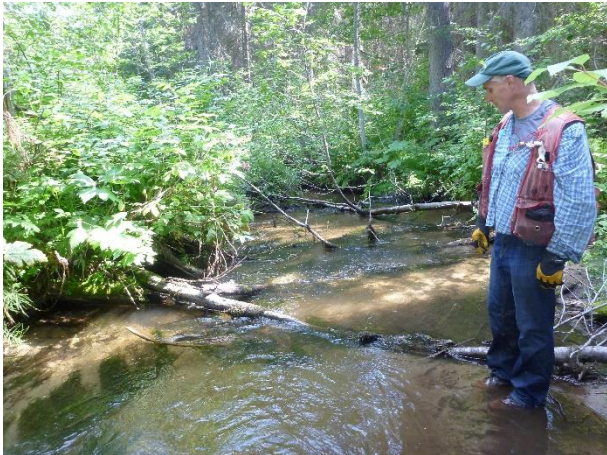
<p>Photo #8</p> <p>Location: 49.82884N 119.9070W Peachland Creek</p> <p>Notes: Reach break. U-shaped valley. Properly functioning mature conifer/deciduous riparian zone. 2% channel slope. Ripple-pool gravel – partially aggregated channel classification. Sand aggradation likely natural. No evidence of sediment sources or disturbance indicators.</p>

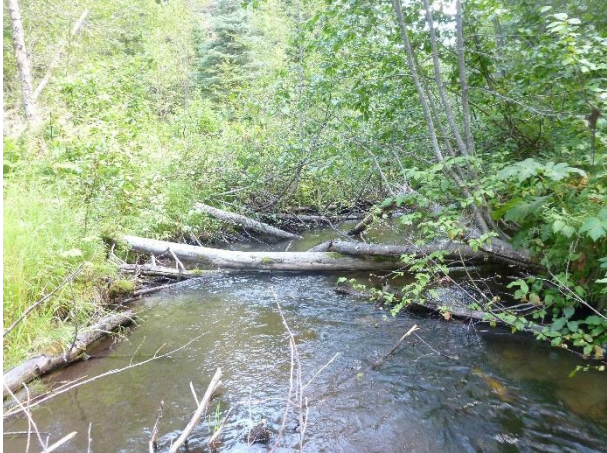
<p>Photo #9</p> <p>Location: 49.8237N 119.8977W Peachland Creek</p> <p>Notes: Reach break. Channel stable with properly functioning mature conifer/deciduous riparian zone and meadow. 5% slope. Cascade-pool cobble. Large wood debris.</p>

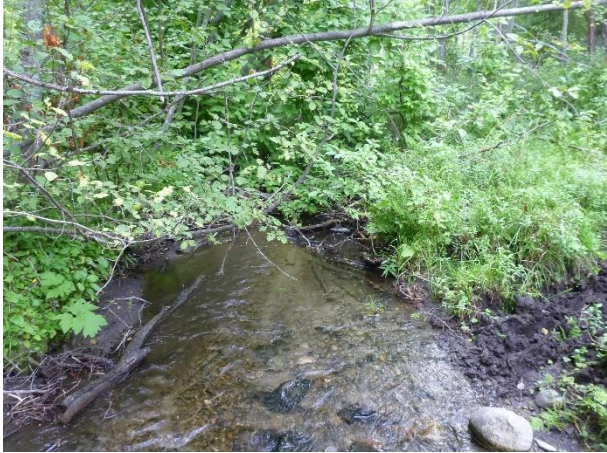
Cattle grazing was evident in the watershed and is impacting channel stability and riparian conditions in Greata Creek (Photos 10, 12 and 14). Based on conversations at the stakeholder meeting, cattle are also entering

<p>Photo # 10</p> <p>Location: 49.79442N 119.899W Greata Creek</p> <p>Notes: Channel is moderately stable with properly functioning deciduous/coniferous riparian zone. Moss covered boulders. 2-3% channel slope. Ripple-pool cobble channel classification. Cattle trampling along bank; defined trails.</p> <p>Risk: Moderate</p>

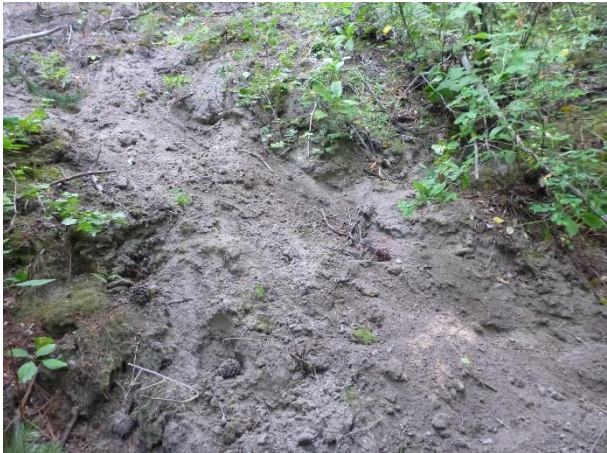
<p>Photo #11</p> <p>Location: 49.79453N 119.8987W Greata Creek</p> <p>Notes: Bank slumping</p> <p>Risk: Moderate</p>

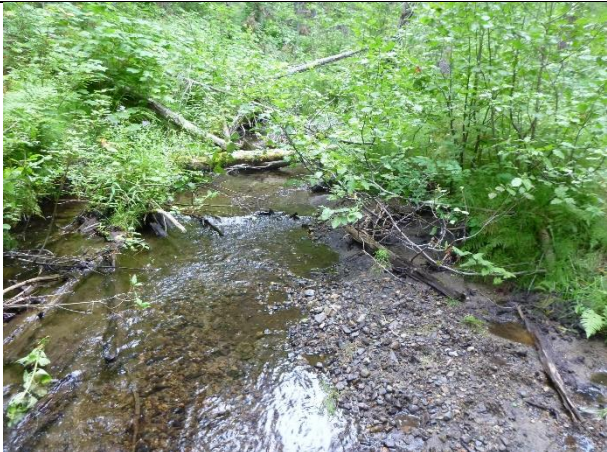
<p>Photo #12</p> <p>Location: 49.79477N 119.88614W Greata Creek</p> <p>Notes: Cattle disturbance, ~5% trampling. Properly functioning mature conifer/deciduous riparian zone and meadow. 2-3% slope. Ripple-pool cobble with aggregated gravel bars. Large wood debris.</p> <p>Risk: Moderate</p>

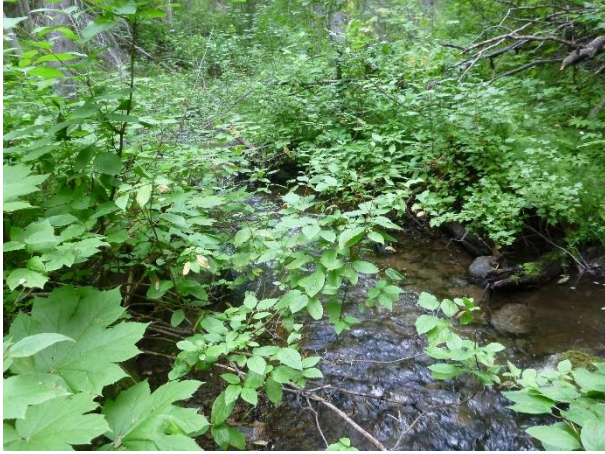
<p>Photo # 13</p> <p>Location: 49.79444N 119.88178W Greata Creek</p> <p>Notes: Stable channel with properly functioning mature conifer/deciduous riparian zone. 4% slope. Cascade-pool cobble with aggregated sand and gravel bars. Large wood debris.</p>

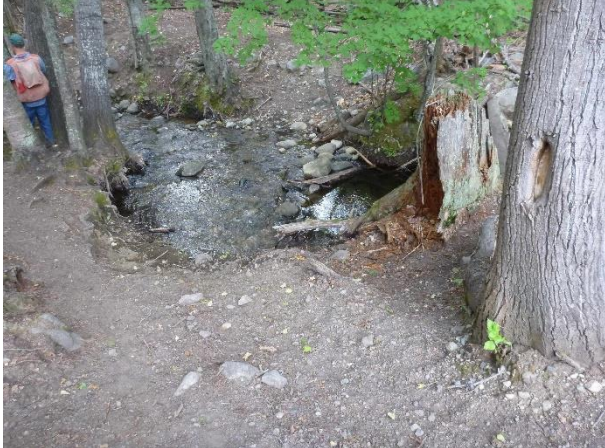
<p>Photo #14</p> <p>Location: 49.796013N 119.85635W Greata Creek</p> <p>Notes: ATV/Cattle crossing. Channel is stable with mature deciduous riparian zone. Cascade-pool cobble channel classification. Disturbed banks for ~8m along channel.</p> <p>Risk: Moderate</p>

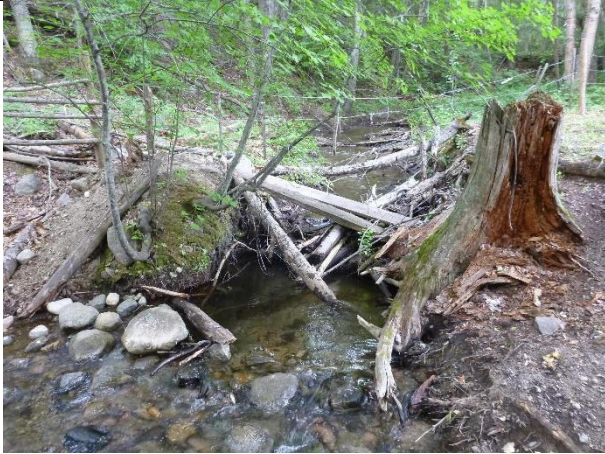
<p>Photo #15</p> <p>Location: 49.796013N 119.85635W Greata Creek</p> <p>Notes: Same as photo 14</p>

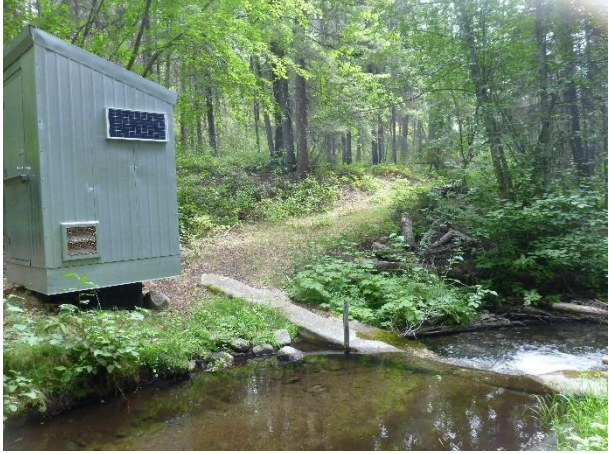
<p>Photo #16</p> <p>Location: 49.79515N 119.855072W Greata Creek</p> <p>Notes: Water Survey of Canada Hydrometric station (08NM173). Concrete weir, find sediment and pebbles on channel bed.</p>

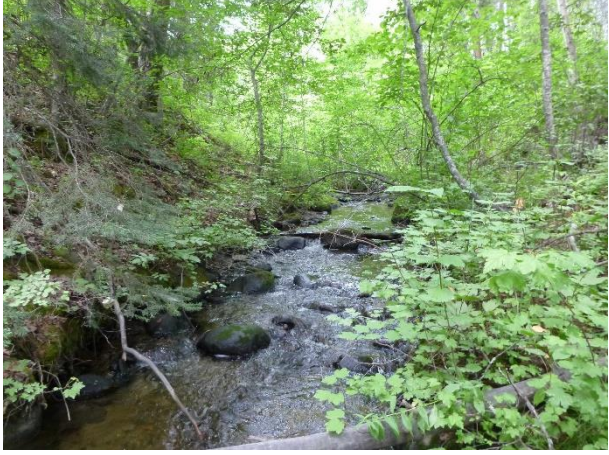
<p>Photo #17</p> <p>Location: 49.79488N 119.853181W Greata Creek</p> <p>Notes: Approx. 50m below Headwaters Rd. Channel is stable with mature deciduous riparian zone. Cascade-pool boulder channel classification. Moss covered boulders.</p>

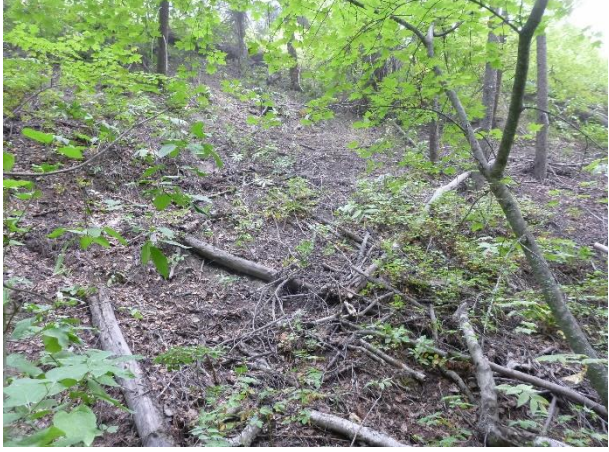
<p>Photo #18</p> <p>Location: 49.794393N 119.84925W Greata Creek</p> <p>Notes: Old failure (3m x 5m x 0.5m), ~ 20m downslope of Headwaters Rd. Evenly vegetated with low surface erosion currently. Sediment bar in creek ~ 15 years old.</p> <p>Risk: Low</p>

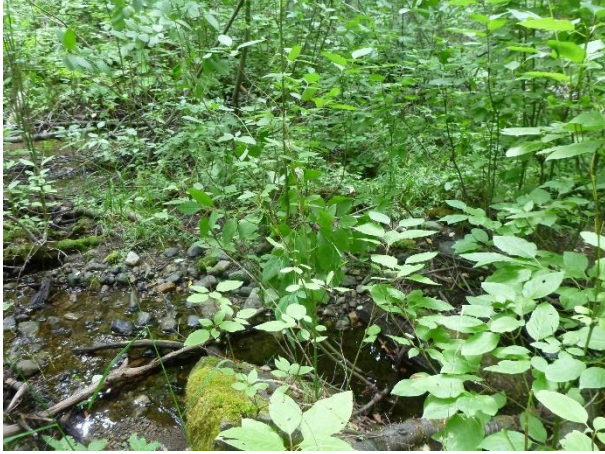
<p>Photo # 19</p> <p>Location: 49.79488 119.84817W Greata Creek</p> <p>Notes: Mid-channel bar, possible bank failure on south side of creek. 3m x 6m x 0.5m</p>

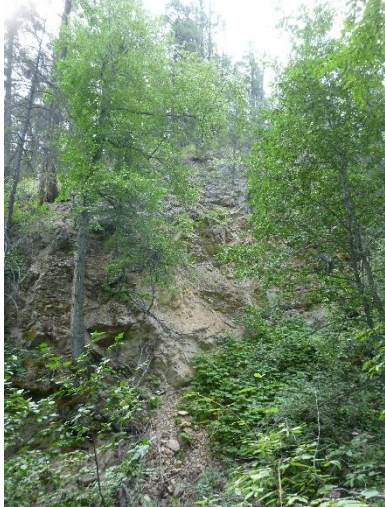
<p>Photo #20</p> <p>Location: 49.79478N 119.84696W Greata Creek</p> <p>Notes: Slope instability on south side, directly connected to Greata Creek. Active over past 5 years. Downstream ~50m of this location the side slopes equal 100%. Some raveling with exposed head scarps.</p> <p>Risk: High Low to moderate sediment input; high risk of occurrence.</p>

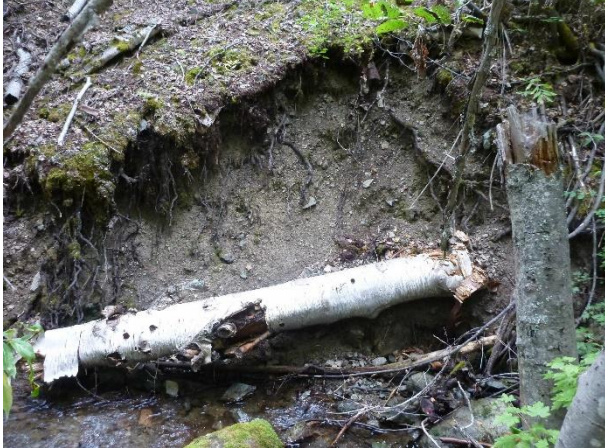
<p>Photo #21</p> <p>Location: 49.79502N 119.8467W Greata Creek</p> <p>Notes: Step-pool boulder, degrading channel classification. 10-15% slope. V-shaped valley 70-90% slope. Small failures, no major sediment sources.</p>

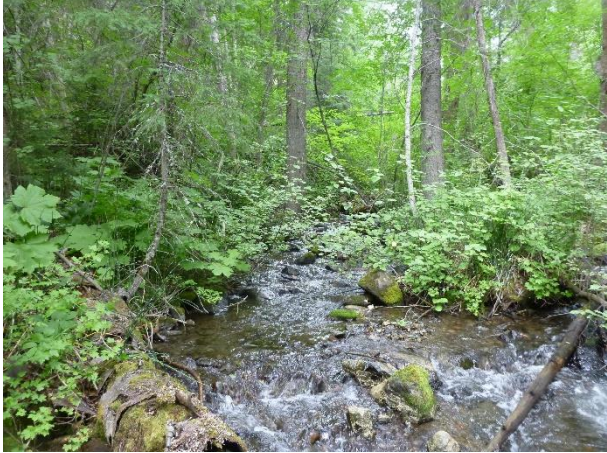
<p>Photo #22</p> <p>Location: 49.79364N 119.841081W Confluence of Greata and Peachland Creek.</p> <p>Notes: Looking upstream Greata Creek. Channel is incised but stable with mature deciduous and coniferous riparian zone. 6% channel slope. ~50m upstream of confluence channel is moderately degraded. LWD. No sediment wedge at confluence.</p>

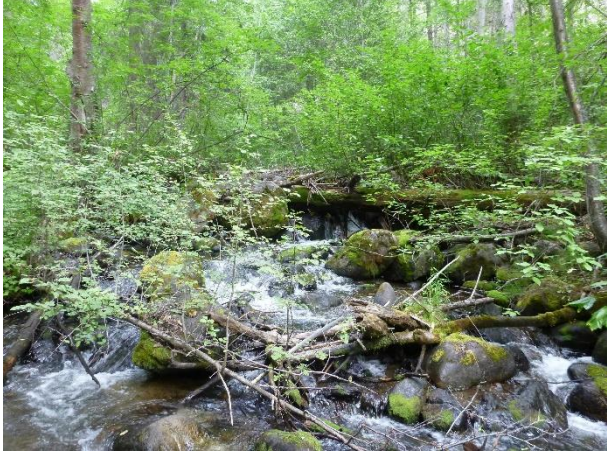
<p>Photo #23</p> <p>Location: 49.79364N 119.841081W Confluence of Greata Creek and Peachland Creek.</p> <p>Notes: Looking upstream Peachland Creek. Channel is stable with mature deciduous and coniferous riparian zone. 8% channel slope. Step-pool boulder. Moss covered logs and boulders.</p>

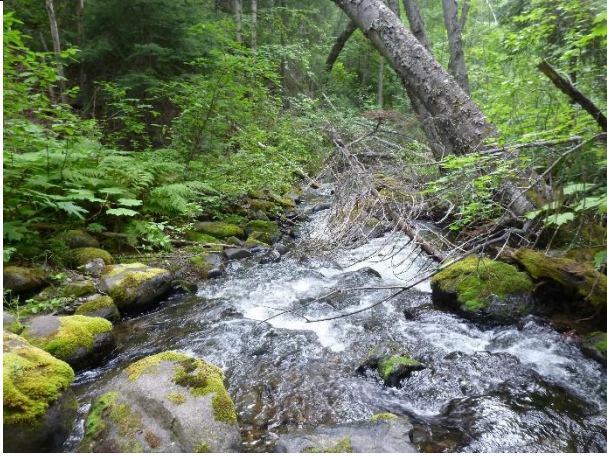
<p>Photo #24</p> <p>Location: 49.79364N 119.841081W Confluence of Greata Creek and Peachland Creek</p> <p>Notes: Looking downstream Peachland Creek. Same as upstream channel characteristics.</p>

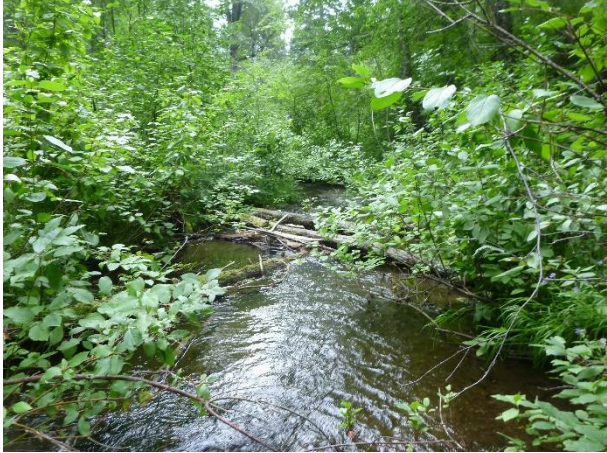
<p>Photo #25</p> <p>Location: 49.79521N 119.841878W Peachland Creek</p> <p>Notes: Channel is stable with mature deciduous and dogwood riparian zone. 3% slope. Ripple-pool cobble, partially aggregated with gravel.</p>

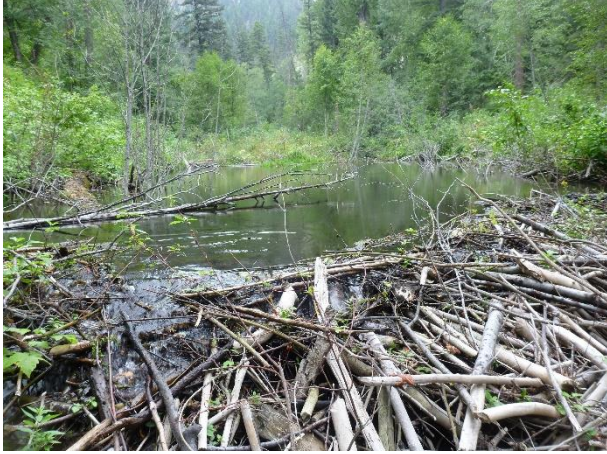
Immediately upstream of the confluence of Peachland Creek and Greata Creek and downstream of the Peachland Main FSR crossing an active beaver dam was identified (photo 26). The pond measures approximately 50 m x 30 m x 1 m. Currently the dam is not a source of sediment to Peachland Creek; however if it were to break it could potentially damage the intake and contribute a significant source of sediment downstream.

<p>Photo #26</p> <p>Location: 49.79364N 119.841081W Peachland Creek</p> <p>Notes: Active beaver dam. Pond measures 50m x 30m x 1m.</p> <p>Risk: High</p>

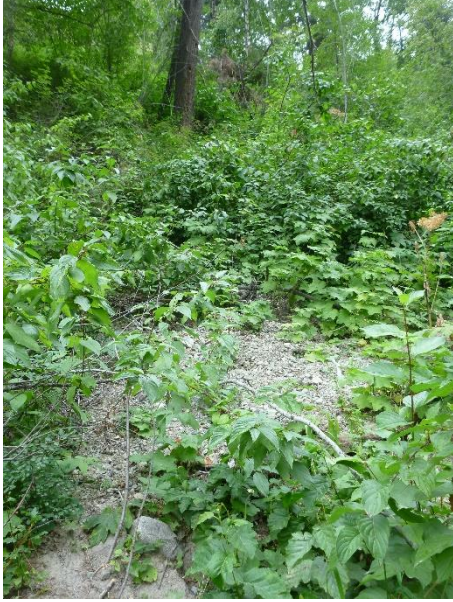
<p>Photo #27</p> <p>Location: 49.79645N 119.844512W Peachland Creek Upstream of beaver dam; west side of creek</p> <p>Notes: Small sediment wedge likely from upper road. 3m x 4m x 0.5m</p>

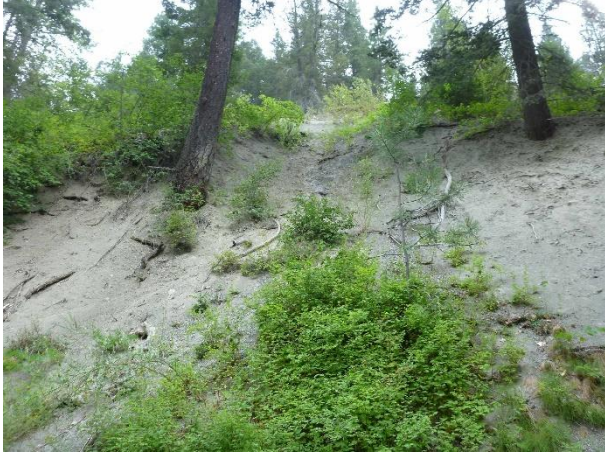
<p>Photo #28</p> <p>Location: 49.79733N 119.84515W Peachland Creek</p> <p>Notes: Large bank failure, likely natural. 50m x 10m x 0.5-1.0m. Fine silt. Vegetated gravel bar downstream. Chronic sediment exposed to rainfall. Head scarp has likely increased due to continued erosion.</p> <p>Risk: Moderate</p>

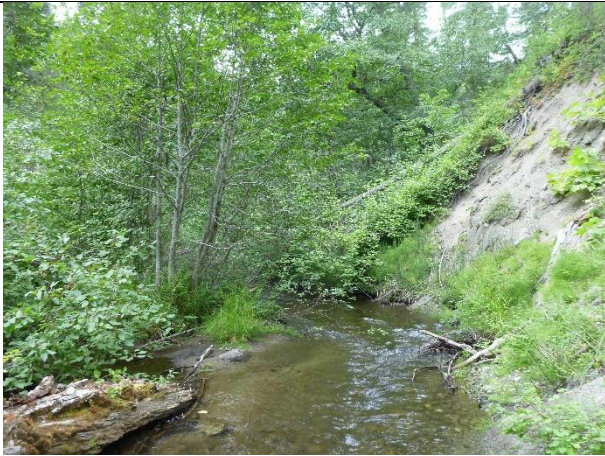
<p>Photo #29</p> <p>Location: 49.79733N 119.84515W Peachland Creek</p> <p>Notes: Same as Photo 28.</p> <p>Risk: Moderate</p>

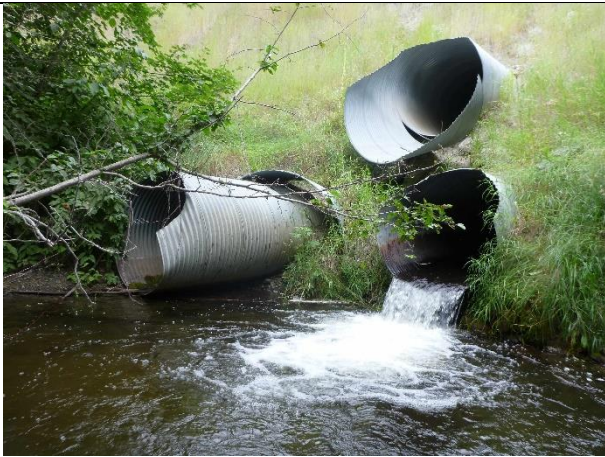
We also noted three culverts at the Peachland Main FSR crossing on Peachland Creek. The invert of the east culvert is buried in the road fill (photo 30 and 31), however this is not a source of sediment to Peachland Creek. The risk to water quality would occur if the active culverts were to be blocked, the road could act as a dam and potentially back up Peachland Creek.

<p>Photo #30</p> <p>Location: 49.79862N 119.846603W Peachland Creek and Headwaters Rd - downstream.</p> <p>Notes: Three culverts (1700mm) downstream of Peachland Main FSR.</p>

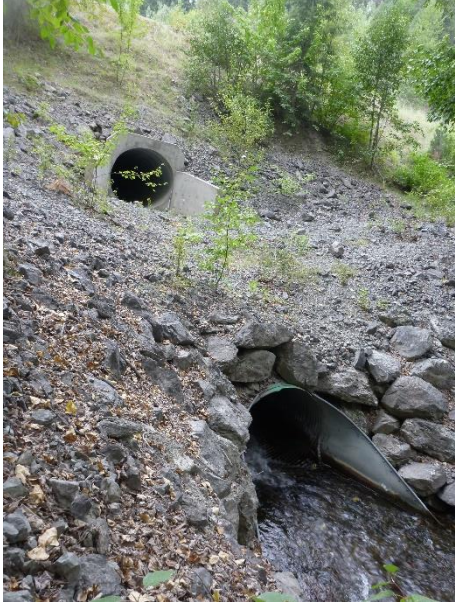
<p>Photo #31</p> <p>Location: 49.79862N 119.846603W Peachland Creek and Peachland Main FSR - upstream.</p> <p>Notes: Two culverts (1700mm) upstream of Peachland Main FSR. Third culvert buried on upstream side of Peachland Main FSR. Visible culverts are clear of obstructions.</p> <p>Risk: Moderate</p>

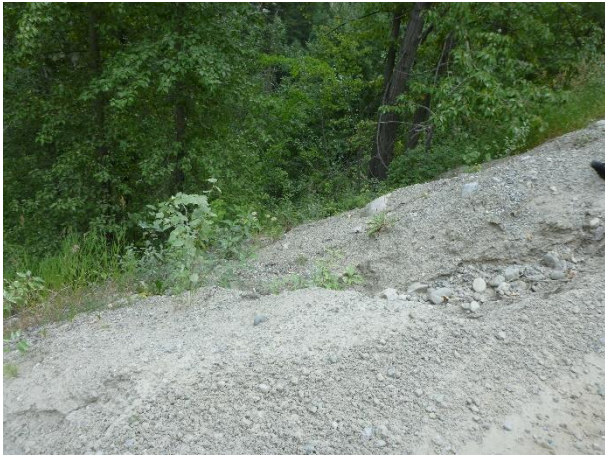
A photograph showing two concrete culverts in a stream bed. The culverts are surrounded by a rocky and gravelly stream bed. The surrounding area is a steep, rocky slope with some green vegetation.
<p>Photo #32</p> <p>Location: 49.797694N 119.846847W Peachland Main FSR</p> <p>Notes: Erosion from outside edge of road. Sediment is connected to the creek below. Due to runoff down road. Fine sediment.</p> <p>Risk: High</p>

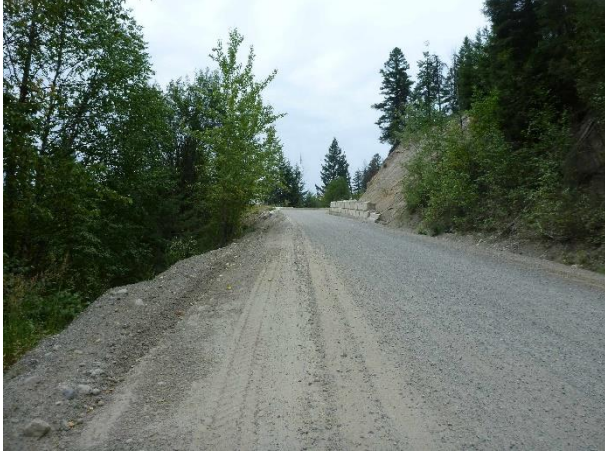
A photograph showing a gravel road with significant erosion on the right side. The eroded area is a mix of fine sediment and larger rocks, leading down a slope.
<p>Photo #33</p> <p>Location: 49.797694N 119.846847W Peachland Main FSR</p> <p>Notes: Looking south from photo 32.</p>

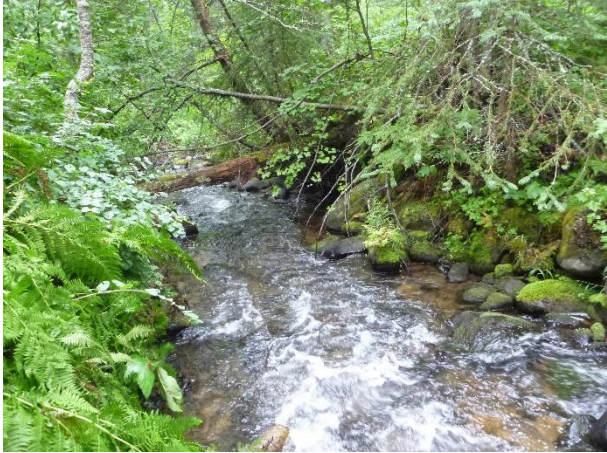
<p>Photo #34</p> <p>Location: 49.81339N 119.860688W Peachland Creek with small tributary entering from north east side.</p> <p>Notes: Channel is stable, confined, with properly functioning mature conifer riparian zone. Moss covered boulder. 6% channel slope. Cascade-pool boulder channel classification. LWD present.</p>

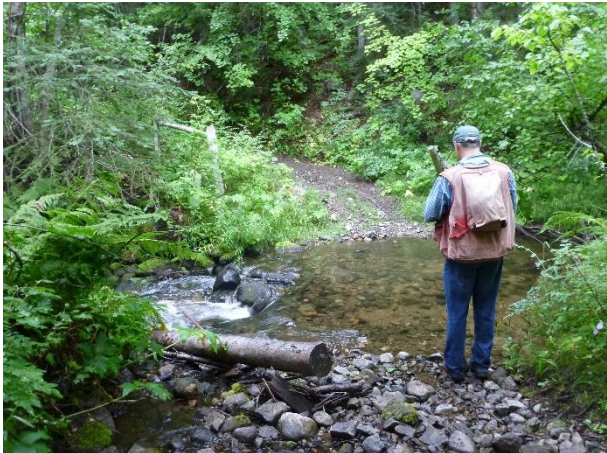
<p>Photo #35</p> <p>Location: 49.81339N 119.860688W Peachland Creek and small tributary to the north east.</p> <p>Notes: Quad and motorized vehicle crossing creek. Trail runs ~8m along tributary.</p> <p>Risk: Low</p>

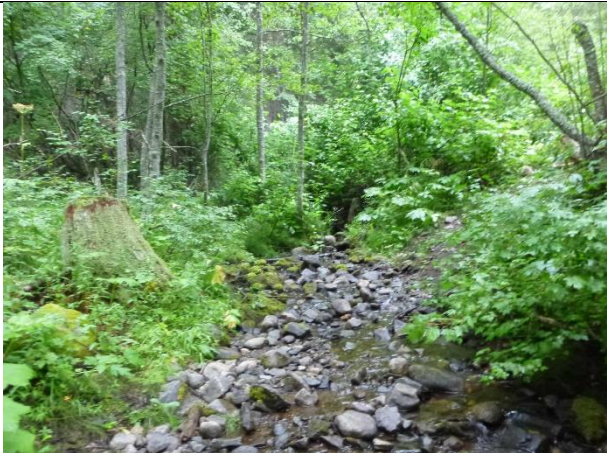
<p>Photo #36</p> <p>Location: 49.81339N 119.860688W Peachland Creek and small tributary to the north east.</p> <p>Notes: Looking upstream of tributary.</p>

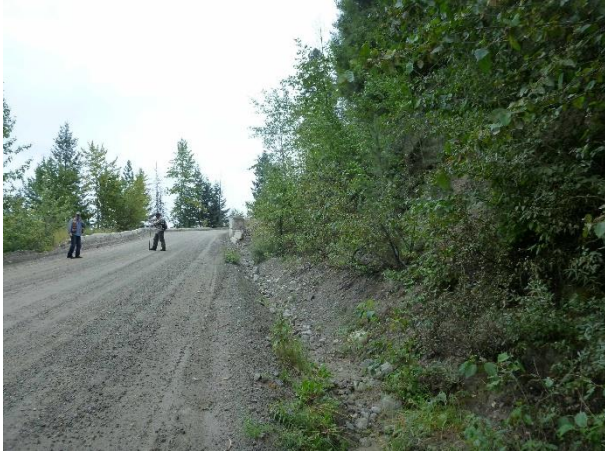
<p>Photo #37</p> <p>Location: 49.797898N 119. 846976W Peachland Main FSR south west of switchback.</p> <p>Notes: Concrete berm on outside edge of road causes runoff to concentrate and results in erosion off the upslope side road. Carries fines to creek along both sides of road.</p> <p>Risk: High</p>

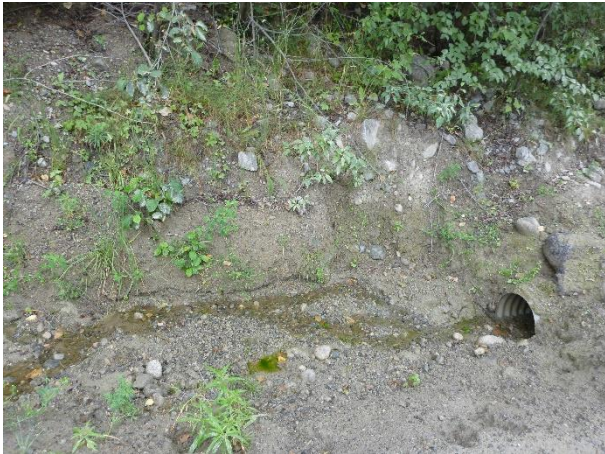
<p>Photo #38</p> <p>Location: 49.797898N 119. 846976W Peachland Main FSR south west of switchback. Ditch line on downslope side of road (west side).</p> <p>Notes: Ditch is periodically cleaned ~2-3 years.</p> <p>Risk: High</p>

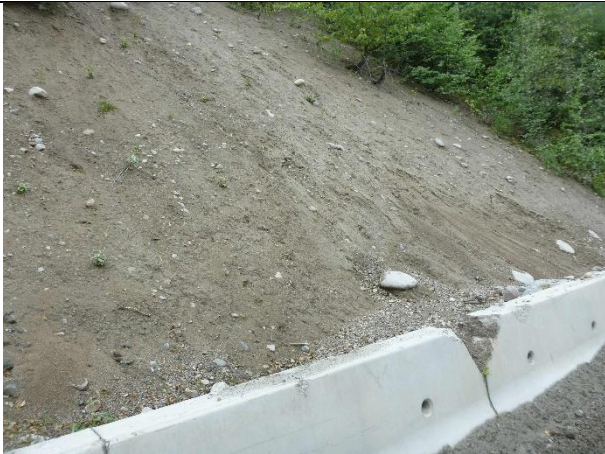
<p>Photo #39</p> <p>Location: 49.797898N 119. 846976W Peachland Main FSR south west of switchback.</p> <p>Notes: Culvert shown in Photo 38 is buried below this lockblock structure.</p> <p>Risk: High</p>

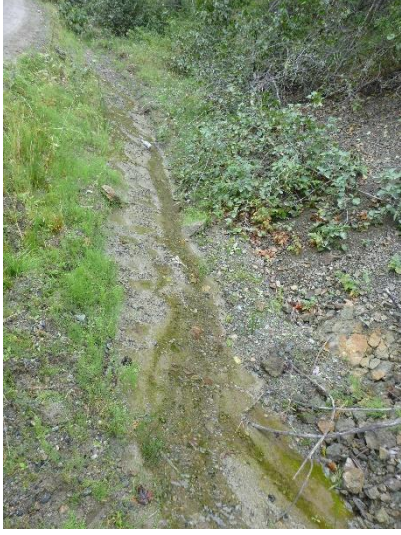
<p>Photo #40</p> <p>Location: 49.79844N 199.8473984W Peachland Main FSR north west edge of switchback (downslope side of road).</p> <p>Notes: Runoff from downslope side of road (outer edge) directly connected to creek. Incised ~30cm. Collects sediment as shown in Photos 37-39.</p> <p>Risk: High</p>

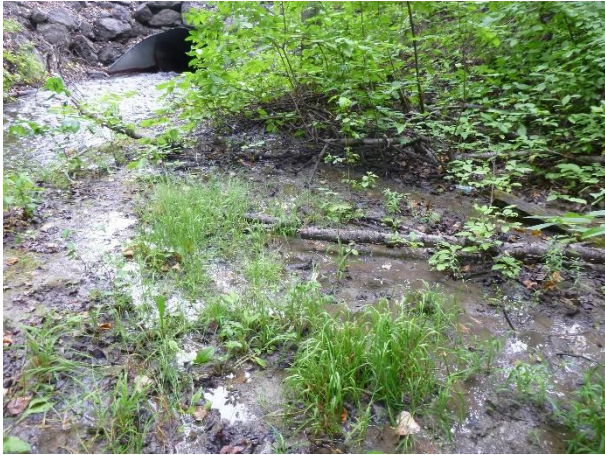
<p>Photo #41</p> <p>Location: 49.79873N 119.846692W Peachland Creek, upstream of Peachland Main FSR crossing at switchback.</p> <p>Notes: Deposition along creek connected directly to runoff from road. Fine clay sediment deposited 2m x 5m x 0.2m along creek.</p> <p>Risk: High (includes location at photos 37-40). High during extreme rainfall events</p>

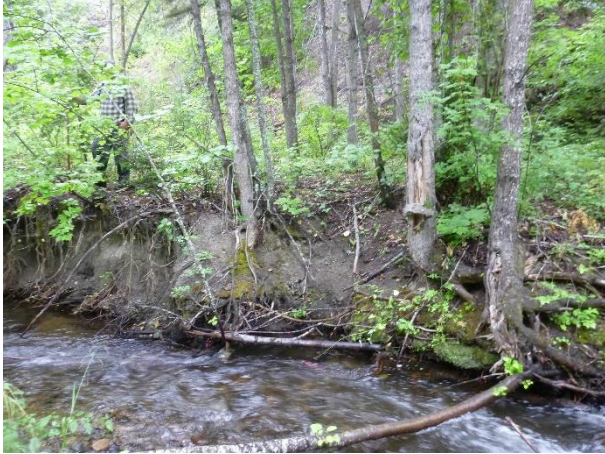
<p>Photo #42</p> <p>Location: 49.7991N 119.8466W Upstream of Peachland Main FSR crossing.</p> <p>Notes: 1.5m high bank erosion. Channel appears to have been diverted – see photo 43.</p> <p>Risk: Moderate</p>

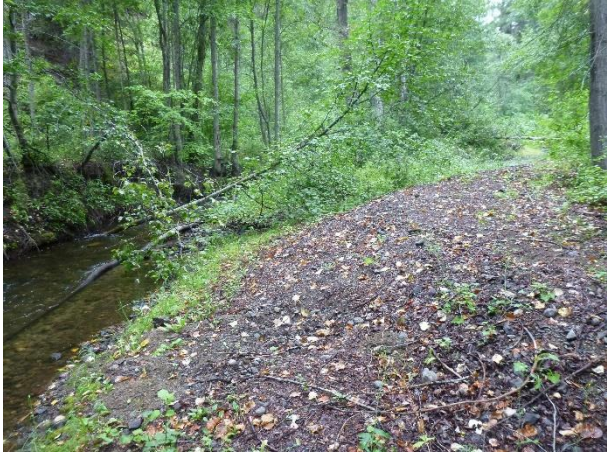
<p>Photo #43</p> <p>Location: 49.7991N 119.8466W Peachland Creek</p> <p>Notes: Berm used to divert channel as shown in Photo 42. Likely a historic placer mine.</p>

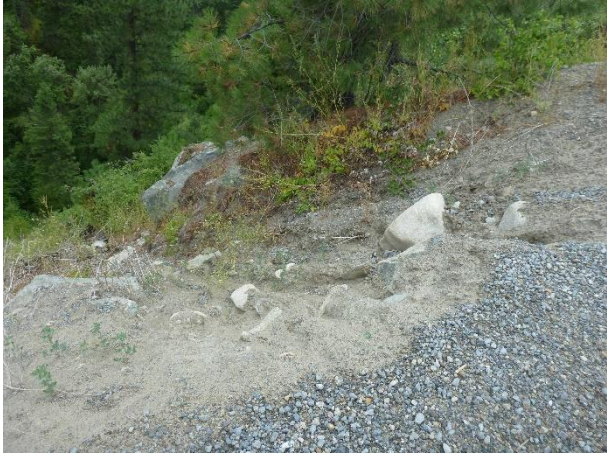
<p>Photo #44</p> <p>Location: 49.78864N 119.83713W Creek side (west-side) of Brenda Mines Rd.</p> <p>Notes: Slope failure from road < 0.5m incised. Resulted in a shallow failure that is connected to the creek. No significant surface road runoff possible.</p> <p>Risk: Low</p>

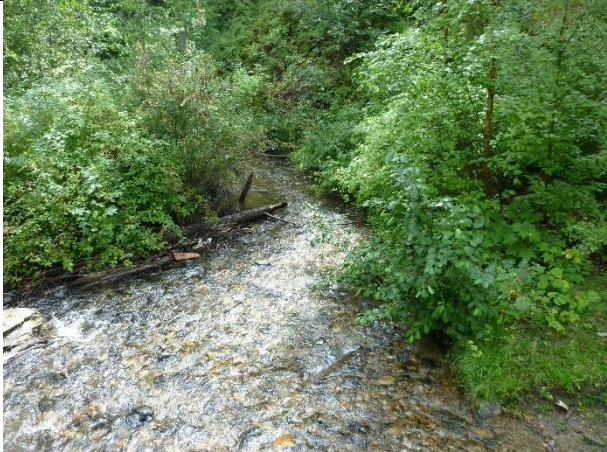
<p>Photo #45</p> <p>Location: 49.75233N 119.80853W Munro FSR bridge at Peachland Creek Upstream of ~330m DOP drinking water intake.</p> <p>Notes: Channel is stable, confined, with properly functioning mature conifer riparian zone. Moss covered boulder. 5% channel slope. Cascade-pool boulder/cobble channel classification. LWD present. Quads have been crossing the creek.</p> <p>Risk: High</p>

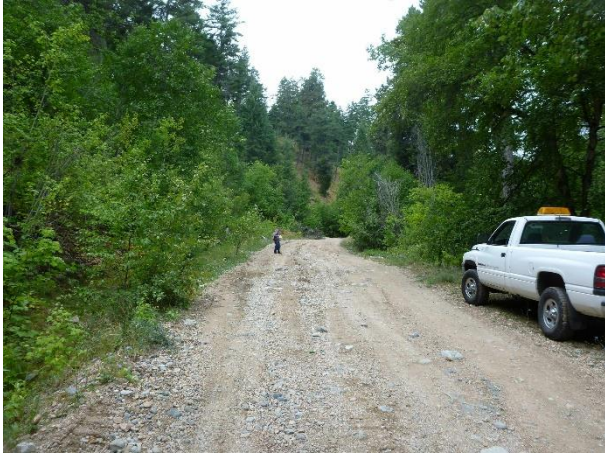
<p>Photo #46</p> <p>Location: 49.75233N 119.80853W Munro FSR on west side of bridge over Peachland Creek.</p> <p>Notes: Road climbs ~10-15% grade. Rill on road surface 0.3m x 0.2m deep. Cross ditches have been in which resulted in rill ditch that connects to creek on inside of road. East side of bridge Munro FSR ~5% grade.</p> <p>Risk: High</p>

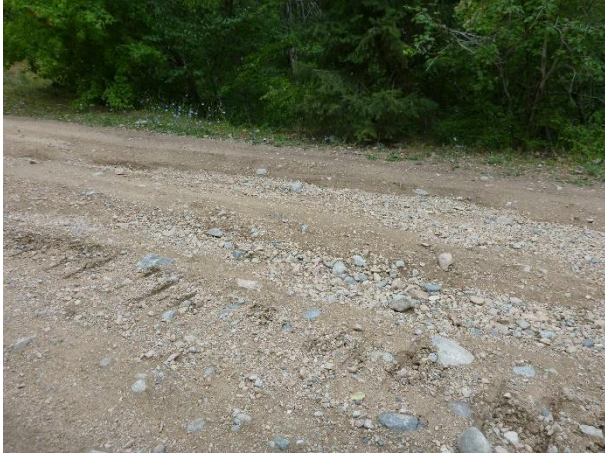
<p>Photo #47</p> <p>Location: 49.75233N 119.80853W Munro FSR on west side of bridge over Peachland Creek.</p> <p>Notes: Close of up rill erosion as shown in Photo 46. Bridge also is a contributor of sediment – suggest surfacing road with gravel and drainage management on road.</p> <p>Risk: High</p>

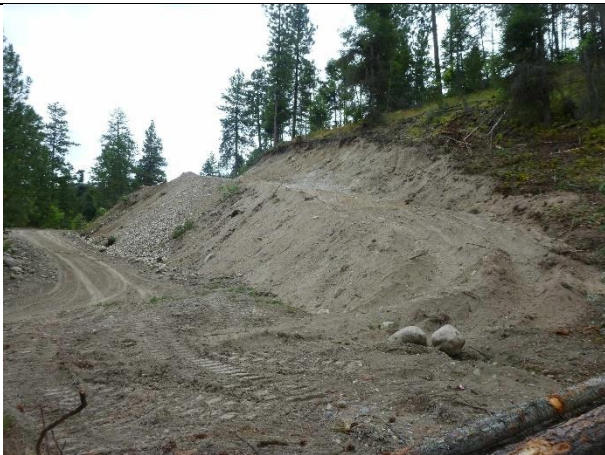
<p>Photo #48</p> <p>Location: 49.75303N 119.81393W Top of Munro FSR switchback.</p> <p>Notes: Newly excavated hill slope, exposed, to widen corner. Runoff is connected to creek.</p> <p>Risk: High</p>

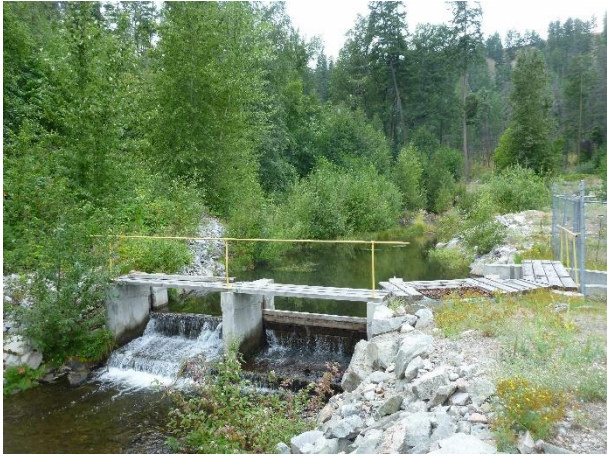
<p>Photo #49</p> <p>Location: 49.7541N 119.80437W DOP drinking water intake</p> <p>Notes: Concrete weir with stop logs to divert water to intake.</p>
